CHECK VALVES FOR COMPRESSOR PROTECTION— A USER'S VIEW

Frank Andrews

Harald B. Carrick

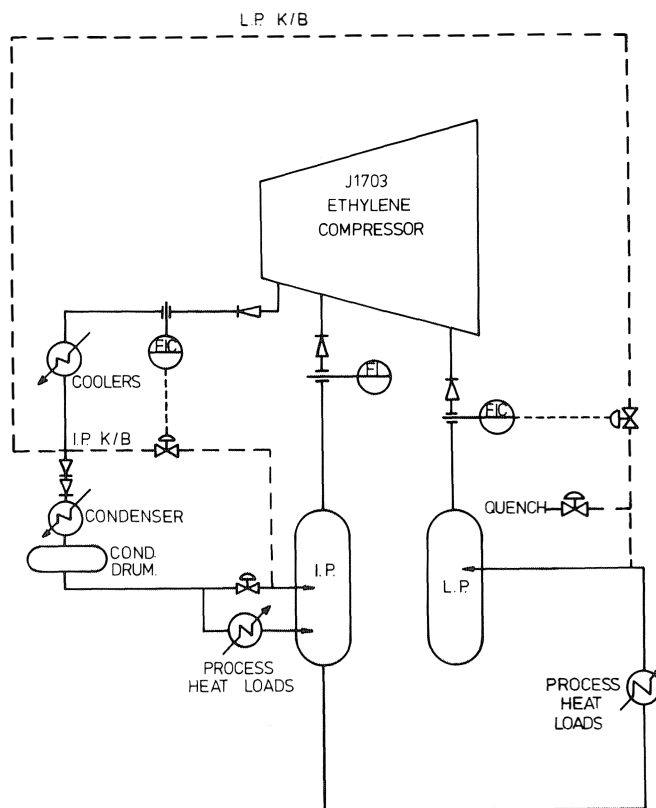
Figure 1. Simplified P and I Line Diagram.

This compressor consists of two sections in a single casing, with each section having four impellers (Figure 1). There are five check valves, three around the compressor and a further two (in series) separating most of the high pressure portion of

the circuit from the machine and its anti-surge piping.

Resulting from this satisfactory experience, the same piston type of valve was chosen for the suction lines of the refrigeration compressors in this new plant. Because the contractor had no previous experience with this type of valve, the valves selected for the discharge were of the typical flapper type, with counterbalance weight and external damper cylinders. The anti-surge loops were similar, although not identical, to those of the earlier plant, and a simplified circuit is shown in

Figure 1. Once again, the commissioning trials were carried out with meticulous attention to detail. On this modern plant, much condition monitoring was fitted, and continuous 42 channel tape recording was implemented. Variables recorded included shaft vibration; axial shaft position; and pressures to suction, discharge and intermediate connections; together with some process temperatures. Extensive records were taken of trip testing, deliberate tripping and all types of conceived malfunction. In addition to the tape recording, continuous multi-pen recorders were used to monitor the speed and other key variables of the refrigeration and process gas compressors on a 24 hr basis. No abnormal rundowns were experienced during the initial testing and commissioning. Three months later, on New Year's Day, when most of the engineering staff were absent, the ethylene refrigeration compressor tripped and ran down to zero speed.

A brief consideration of energy levels serves to show the importance of the check valves in separating sections of the refrigeration system. This is illustrated with reference to the ethylene refrigeration system discussed in this paper (Figure 1).

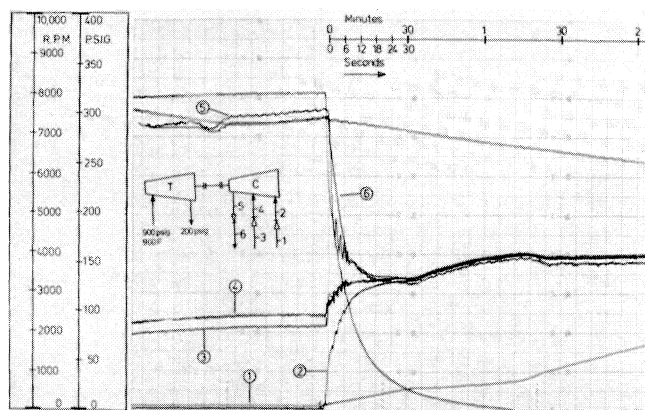
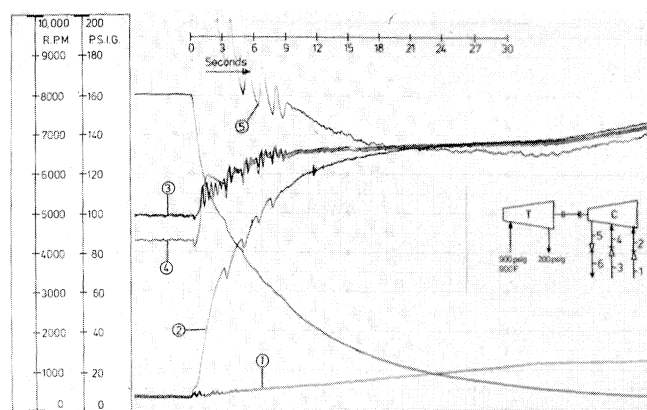
Figure 2. Speed and Pressure Traces, Ethylene Compressor, 5 April 1980.

Consider first a typical "normal" rundown, where there is no reverse rotation: the record of 5 April 1980 (Figures 2 and 3). Note that the speed decreases much more rapidly than the turbine solo (21 sec, compared with 95 sec from 7000-1000 rpm). The speed decrease is approximately linear for about 0.7 sec, and then follows a nearly exponential form. From Pressure

Traces 1 and 2 (Figure 3), it can be seen that the LP suction check valve closes almost immediately, as does the IP suction check valve (Traces 3 and 4, Figure 3). The discharge check valve closes after about 0.5 sec (where Traces 5 and 6 diverge, Figure 2). The IP suction valve re-opens at 3.5 sec after trip, when the pressure equalizes across it; from then on, the pressures on either side are essentially identical, and the valve remains open. The pressure ratio across the machine reduces rapidly, and both sections of the machine surge, as shown by the pressure swings on Traces 2, 4 and 5, Figure 3. The discharge check valve re-opens about 10 sec after the trip, when the external pressure has been reduced by the action of the kickback valves. Surging then ceases, as a small forward flow is established, and frictional decay follows with a $k \approx .012$. (See Appendix for a definition of the deceleration rate, k).

The results of the trips are shown in Figures 2-7. These charts have been obtained by replaying tape recordings. Speed is shown on every chart (usually 8,000 rpm before trip, falling rapidly thereafter), and it is a common factor enabling cross-reference between different charts of the same event.

Up to seven pressure traces are shown. Six of these (identified as 1-6 on the charts) are from pressure transducers on either side of the three compressor check valves. The seventh pressure trace (where shown) is from a transducer placed downstream of the two check valves in series. The pressures on either side of the machine check valves are vital in understanding what was happening. When a check valve is open and the flow is steady, the pressures on either side of the valve will run parallel; e.g., Traces 3 and 4, Figure 2. Any offset between the traces will be due to pressure drop, particularly if there is other flow resistance between the measuring positions, or transducer zero error. When the valve closes, the pressures diverge, either dramatically, such as Traces 1 and 2, Figure 2, or more gradually. In order to give a complete picture, all six traces must be shown on the same chart. As a consequence, the charts which show the full pressure range (Figures 2, 4 and 6) are condensed, and, in each case, a second chart (Figures 3, 5 and 7) is presented on an enlarged scale to allow closer study of the detail and to aid understanding of the complete record. A detailed description of the sequence of events, for both a normal rundown and a reverse rotation, follows.

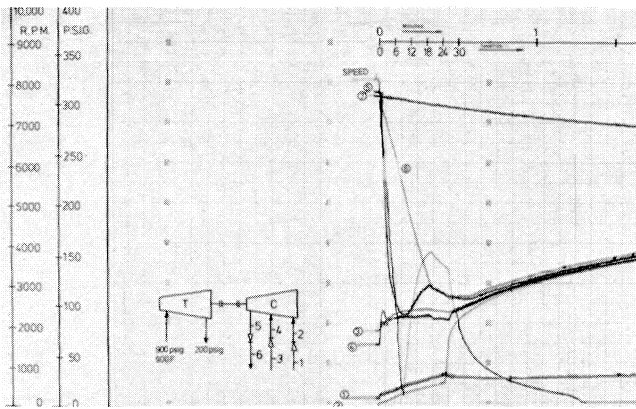
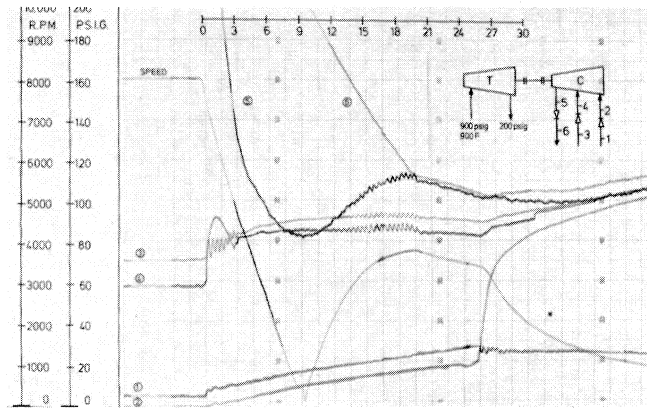
Figure 4. Speed and Pressure Traces, Ethylene Compressor, 31 March 1980.

A typical reverse rotation is shown in Figures 4 and 5—the record of 31 March 1980. The speed reduces even more rapidly, 6.9 sec from 7000-1000 rpm. The speed curve (Figure 5) passes through zero at 9 sec after trip. Because the speed detector is unable to sense direction of rotation, the reverse speed that follows is shown reflected about the zero speed line. The kick in the speed trace near zero rpm is also due to the

speed detector. The speed curve is very nearly linear through to -1500 rpm. The discharge valve closes almost immediately (Traces 5 and 6, Figure 4), as does the IP suction valve (Traces 3 and 4, Figure 5). However, the LP suction valve does not close for about 25 sec (Traces 1 and 2, Figure 5). The IP suction valve re-opens at 3 sec after trip, when the pressure inside the machine has fallen sufficiently. This allows flow *into* the IP suction and *out of* the LP suction, and, as the compressor passes into the reverse rotation regime, the first (LP) section of the compressor works as a radial inflow turbine, driving the string backwards. At the same time (from 9 sec after trip), the second (HP) section of the compressor behaves as a forward vaned compressor, surging as it attempts to compress gas from the IP suction through to the discharge (Traces 3, 4 and 5, Figure 5). At 20 sec after trip, the delivery check valve opens, allowing forward flow from the HP section of the compressor; and, for the first time, the reverse rotational speed starts to decrease because work is being done by this section of the compressor. At 25 sec after trip, the LP suction check valve opens (Trace 2, Figure 5). This removes the driving force for reverse rotation by preventing reverse flow through the LP section of the compressor, and frictional speed decay begins.

Note that the rate of decay ($k \approx .011$) of the reverse rotation is the same as that of forward rotation ($k \approx .012$).

Traces 2 and 4 of Figure 5 show that the driving force for reverse rotation, namely the pressure differential across the LP section of the compressor, has not reduced significantly by the time the acceleration is beginning to reduce, at 15 sec after trip. This demonstrates that other, limiting effects are involved, such as the stalled torque exerted by the second (HP) section of the compressor and the reduction in driving torque implicit in Equation 1.

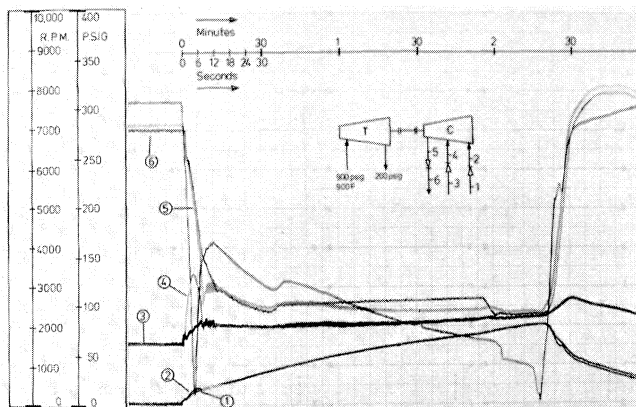
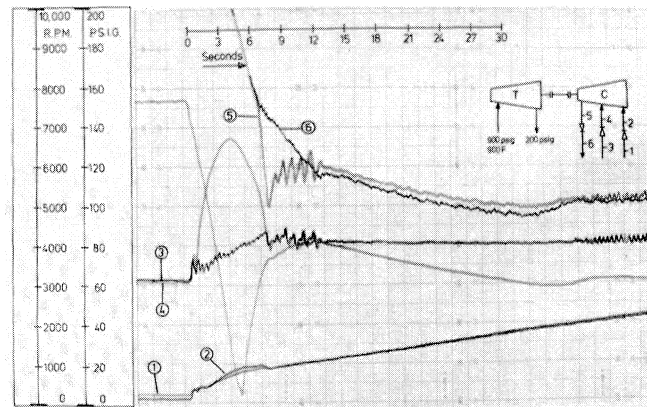
Figure 6. Speed and Pressure Traces, Ethylene Compressor, 18 June 1982.

In late 1981, all check valves were inspected and found to be free to move by hand. This was not the end of the problem, however, as Figures 6, 7 and 8 show. On this occasion, the LP suction check valve did not close throughout the duration of the trip, and the discharge check valve also failed to close for seven seconds. As a result, this was the most rapid deceleration to date. Figure 8 shows shaft vibration from the drive end of the compressor. The peaks in vibration between 8 and 13 seconds after trip are associated with the surging of the HP section of the compressor prior to the re-opening of the discharge check valve. Despite exceeding the (forward) critical speed in reverse, the shaft system still appears to be stable.

Why the LP suction valve malfunction is unknown. There are three hypotheses, all associated with the low operating temperature:

- Loss of internal clearance
- Inadequate bearing material
- Frozen compressor lubricating oil

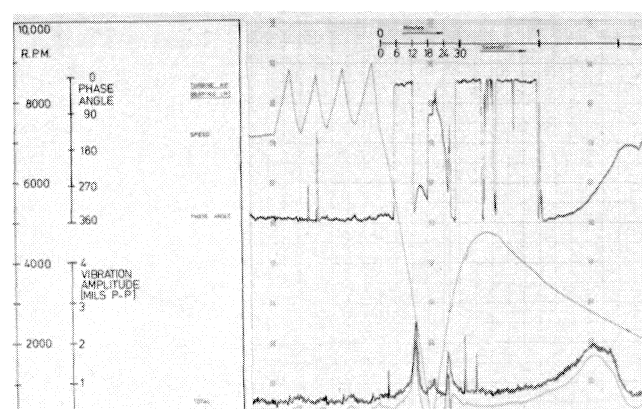
Figure 9. Speed and Vibration Traces, High Pressure Cracked Gas Compressor, 21 March 1981.

down). The major differences are the greater inertia and lower windage of the condensing turbine which drives the HP cracked gas compressor. In the trip with reverse rotation shown in Figure 9, the speed curve is nearly linear to -3000 rpm, and the duration from 7000 to 1000 rpm is 15.6 sec.

No pressure traces have been recorded on this compressor, but it is reasonable to assume that the discharge check valve took longer to close on 21 March 1981 (the case illustrated in Figures 9 and 10) than in the other two recorded instances of reverse rotation on this machine.

Figure 9 shows the speed, total and filtered ($1 \times$) vibration and phase angle from the turbine HP bearing (H) probe. The turbine first critical is shown clearly three times: in forward, reverse, and reverse rotation, in rapid succession! Also shown is the 180 degrees phase shift in the vibration signal as the speed passes through zero, a clear demonstration of the reversal of rotation.

One clear suggestion from Figures 5, 8 and 9 is that the speed in reverse is becoming asymptotic to a maximum value. This leads us to look for the physical basis of such a maximum. The velocity of gas flowing backwards through the stationary passages of the compressor will be limited at the diffuser throat to the speed of sound. With vaneless diffusers and radial inlet guide vanes, no swirl should be acquired by gas flowing back into the compressor from the discharge or an intermediate suction pipe. Therefore, the backward flow will be unable to accelerate the rotor beyond zero incidence (Figure 12); and, hence, depending on the temperature (and therefore speed of sound) of the gas and the impeller outlet angle, a maximum speed in reverse can be calculated.

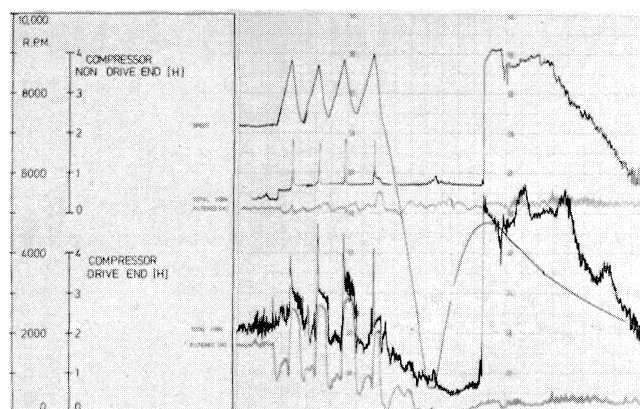
Figure 10. Speed and Vibration Traces, High Pressure Cracked Gas Compressor, 21 March 1981.

Figure 10 gives a beautiful example of one of the possible unpleasant consequences of reverse rotation—whirl. This figure shows one channel of vibration from each end of the compressor, total and filtered ($1 \times$). Prior to trip, the effect of torque centering and unlocking of the coupling on the compressor drive end vibration can be seen as the speed oscillates over a 1500 rpm range. At just below peak speed in reverse, the compressor rotor starts to whirl, and whirl continues until reverse rotation has decayed almost to zero. The frequency of this non-synchronous vibration is about $0.45 \times$ rotational speed throughout.

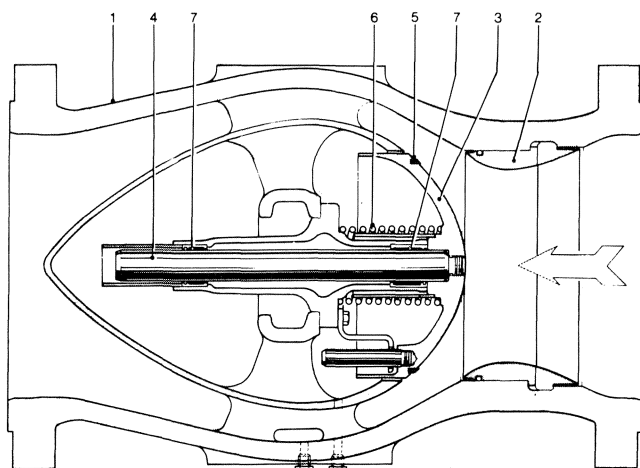
Figure 11. Cross Section of Piston-Type Check Valve (Valve Open).

malfunctioning of the discharge check valve. This is a piston (low pressure drop) valve (Figure 11). When the valve was inspected at a turnaround in 1981, the space around the sliding shaft between the internal bearings was found to be full of polymer. This resulted in considerable friction, resisting correct valve operation. The assumption of the design contractor that this was a "clean duty" was obviously incorrect. A dual flapper type valve was immediately purchased and installed, and no further problems have occurred.

The aerodynamic design of the internal piston type valves makes good economic sense, and our experience in general is good. However, these valves should not be used for duties which might not be clean. Spring rates must be chosen so that they are fully open at a maximum of 60% of design flow.

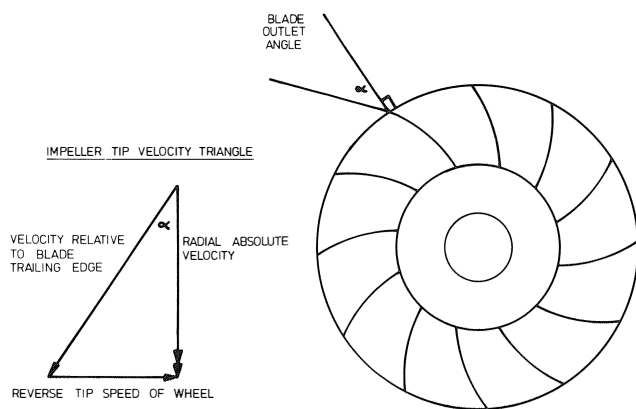
Figure 12. Impeller Tip Velocity Triangle.

$$N_{\max} = \frac{720 a \tan \alpha}{\pi d} \quad (1)$$

Obviously, the higher the value of α (i.e., the more the backward lean), the higher the maximum reverse rotational speed can be.

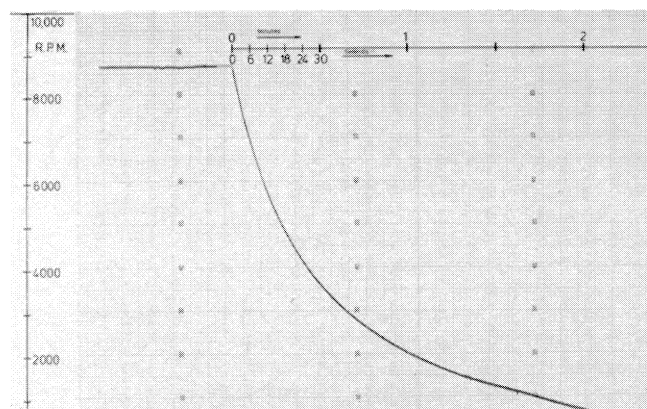
Figure 13. Speed Trace, Ethylene Compressor Turbine Solo, 27 July 1979.

This exponential decay of speed describes well what happens to a solo turbine (Figure 13), where the value of k obtained would be about 0.004 sec^{-1} .
